SAFETY ALERT

Campus Incident—Fire

RISK MANAGEMENT & SAFETY

Date: September 2014
Category: Fire/Chemical Reactions
RMS Contact: Eric Kloss, ekloss@nd.edu

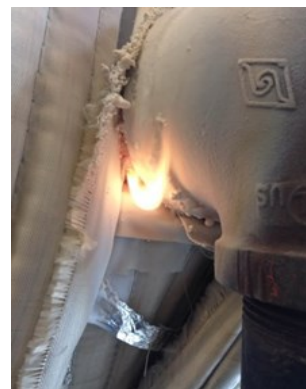
A small fire occurred on Wind Tunnel. The fire was at the junction of the cool air intake and the aft-duct work on an air moving system. It was extinguished by the lab personnel using a fire extinguisher. There were no injuries or property damage.

- The gap between the auxiliary blower access and the aft-duct work was filled with ceramic rope rated at 2000 °F. The ceramic rope was coated with 2 layers of gasket maker rated at 700 °F “intermittent”. The wind tunnel is covered by fiberglass insulation rated at 1800°F.
- The air system can reach temperatures around 700 °F through air movement, no air heaters are used in the system.
- The gasket maker was applied approximately 2 weeks prior to the fire and 24 hours dry time was given between each coat.
- The air movement system was operated for 12 hours at 200 °F the day before the fire without incident.
- The gasket maker is used as a gasket material in other areas of the system.

The gasket maker ignited due to the presence of heat from the system. The temperature of system reached the maximum temperature of the gasket maker (700 °F). Additionally, the gasket maker was not used as designed. The material was applied in two thick layers which is greater than a standard gasket would require. This may have prevented the material from curing properly.

- Permanently weld the auxiliary blower access to the aft-duct wall.
- Perform a bench test of the gasket maker to determine if this material can be used as a gasket in other areas in the system. Test the material to the worst case temperatures of the system and worst case thickness required for the material.
