SAFETY ALERT

Incident Type: Chemical Burn

Date: December 6, 2013

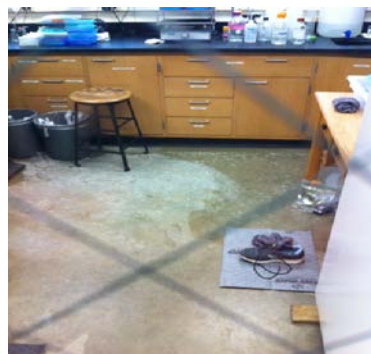
Photo 1:

The lab manager unpacked and placed nine bottles of glacial acetic acid (500 mL poly-coated glass bottles) onto the top shelf of a cart in order to move them into the lab for storage. The bottles were placed along one side of the cart. The cart was moved approximately 30 feet from the unpacking area to the storage area. After moving the cart into the lab storage area, the lab manager began to unload the bottles when the cart tipped over. Nine bottles fell to the floor (See Photo 1 of spill area). Five bottles spilled acid due to the bottle caps breaking or the glass bottle cracking. The other four bottles were cracked.

The graduate student was contacted by acetic acid because the cart that was used to transport the acid bottles tipped over resulting in the bottles striking the floor, breaking open, and splashing the student. The cart tipped over because the load was placed on the top shelf and to one side of the cart. It was determined that the unbalanced cart may have been bumped or moved during unloading causing it to tip over.

1. Communicate this event to this PI's lab personnel and provide instruction to distribute the load when transporting material on carts.
2. Conduct PPE training for this PI's lab personnel, instructing them in the requirements when PPE is necessary.
3. Communicate to lab personnel that it is recommended to keep chemicals in their original shipping container until at the final storage point if practical e.g., place shipping box on cart.
4. Develop back-up ordering process to eliminate stockpiling of chemicals.
5. Develop safe chemical transport procedure that includes proper loading of carts and secondary containment.

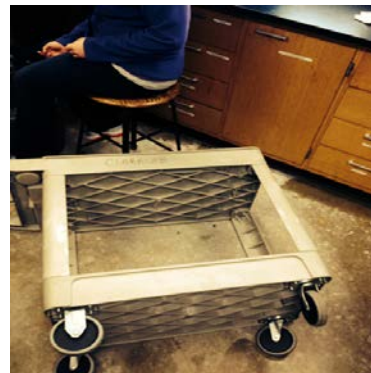
Photo 2:

A graduate student was in the area completing paperwork unrelated to the storing of the Acetic Acid (See Photo 2). The acid splashed and contacted her ankle. She was wearing long pants. Both the lab manager and graduate student went to the Wellness Center for examination. Both employees were observed and released back to work with no required treatment.
