# SAFETY ALERT

## Forklift Battery Incident

**Date:** July, 2019  
**Category:** Forklift Safety

Document #: 19-0014

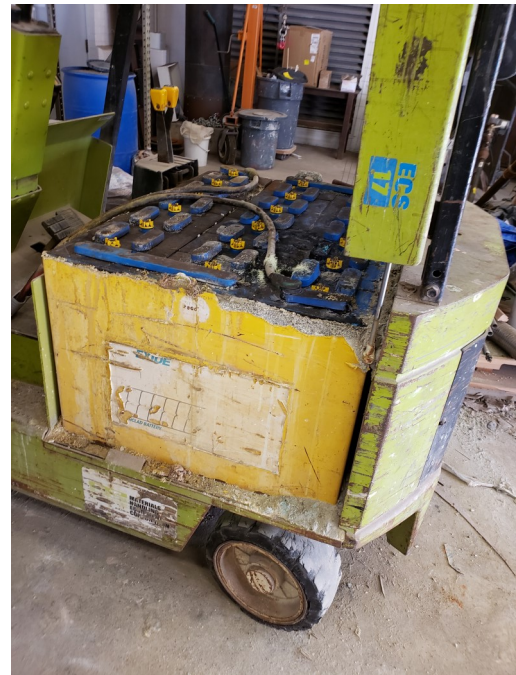
During the transition of forklift maintenance to Morrison Industrial Equipment Co., a forklift was found with a smoking battery. The forklift was perpetually left on the charger and the battery was not properly maintained or inspected. Crystals had formed on top of the battery which began to smoke. Acids that had leaked from the battery corroded the battery container and parts of the forklift, requiring significant cost to repair.

- Forklift left on charger continuously
- Water not added to battery consistently
- Adding of water was performed at improper time causing boil-overs to occur
- Battery acids corroded forklift and damaged other battery components
- Crystals formed on battery cells leading to smoke

- Improper maintenance of forklift battery
- Lack of proper training and knowledge
- Lack of maintenance program

- RMS to work with Morrison Industrial Equipment to establish a routine maintenance process to ensure batteries are being properly maintained.
- Morrison to install Level-lite Watering Indicators on powered industrial trucks to ensure that batteries have adequate water levels prior to use.
- Morrison to take over process of adding water to batteries after charging is complete—ND employees no longer need to perform task.
- Provide training to forklift operators on proper battery maintenance and operator refresher training, if necessary.
