SAFETY ALERT

Incident Type: Electrical Shock injury

Location : North Dining Hall

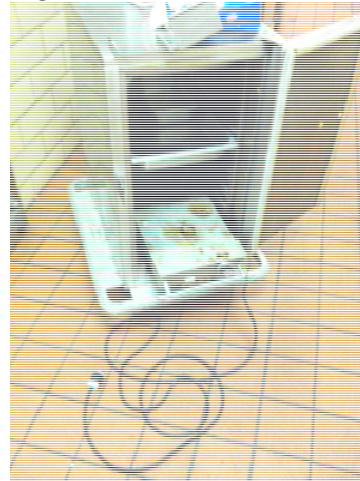
Figure 1:

Hot Holding Box.

- The stainless steel prep table became energized unexpectedly. A hot holding box was nearby and the cord for the hot holding box was found to be damaged.
- The cord was in contact with the stainless steel table and provided an electrical shock when the employee placed both of his hands down on the table.
- The age and wiring methods used for the electrical outlet that the hot holding box was plugged into were questionable .

An electrical outlet existed that relied on the conduit to act as a ground. This practice was more common when the building was constructed. A hot holding box contained a cord with damaged insulation and was plugged into this electrical outlet. The cord was in contact with the stainless steel table and when an employee came in contact with the table he received an electrical shock.

1. Replace the cord of the hot holding box. **Complete**
2. Food Service maintenance inspect cord and plug equipment in the facility looking for conditions that could cause electrical shock. **Complete**
3. Add a grounding wire to the electrical outlet involved in incident . **Complete**
4. Inspect north dining hall electrical outlets and determine that grounds are in tact. **Complete**
5. Communicate incident to employees. **Complete**
