SAFETY ALERT

Incident Type: Temperature / Scald injury

Location : North Dining Hall

Date: July 2014

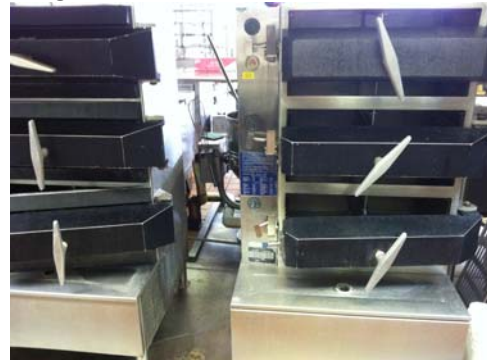
Figure 1:

Dining hall steamer units.

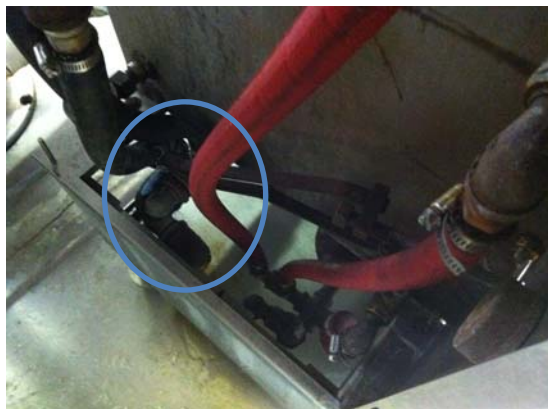
Figure 2: broken part on the pushrod linkage led to the steamer not draining when it should have.

- The pushrod linkage was found to have a broken stopper part. This allowed the linkage to get in the wrong position and even though the pushrod was in the “off” position the valve did not open.
- The steamer units contain pressure gauges which are difficult to read due to condensation and are rarely referenced by those who operate the equipment.
- Preventative maintenance for steamer units does occur but focuses on parts that need additional upkeep such as door hinges and door seals.

A component failure caused an employee to believe a steamer was drained when it wasn't. Turning the handle to release the compartment door was difficult but the employee continued without recognizing the increased resistance from the hot water behind that compartment door and didn't recognize the pressure reading on the pressure gauge. The pushrod was in the “off” position which would normally mean that the valve had opened and any steam and water has drained out the bottom of the unit.

1. Inspect similar steamer units on campus to verify the linkage components are in good condition. **complete**
2. Replace the linkage part on the equipment involved in this incident. **Complete**
3. Communicate to employees if there is additional resistance when attempting to open a compartment door, you must stop and notify food service maintenance. **Complete**
4. Replace all steamer pressure gauges at North Dining Hall. **Complete**
5. Include an inspection of pushrod linkage in quarterly steamer preventative maintenance. **Complete**
6. Engineer representing equipment manufacturer inspect the equipment and determine cause of component failure. **Waiting final report.**
