SAFETY ALERT

Waste Acid Bottle Explosion

Event: April 18, 2016
Category: Chemical Incident
RMS Contact: Lisa Phillips, Bognar.6@nd.edu

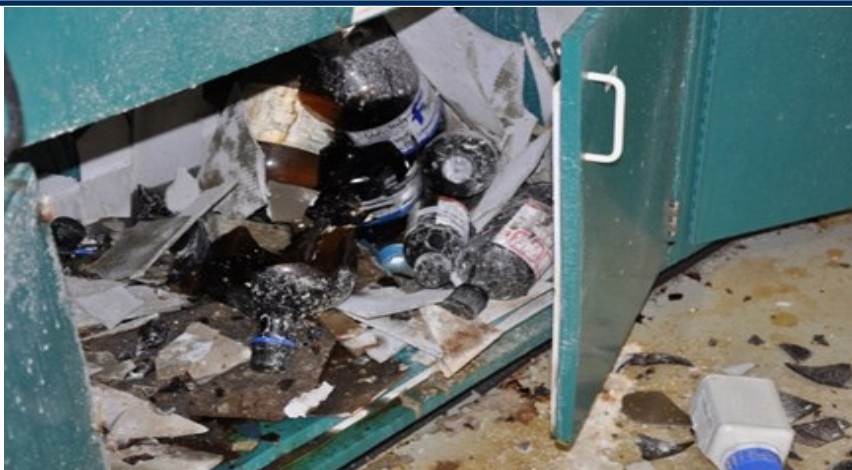
An explosion occurred when a waste nitric acid bottle became over-pressurized after a delayed chemical reaction. The bottle was stored in a cabinet under a hood with other waste containers that were destroyed in the explosion. The laboratory was unoccupied at the time.

- The acid waste bottle contained nitric acid used to clean glassware.
- Ten waste bottles containing various metals in acid or methylene chloride were destroyed.
- Graduate student noticed pressure release when the bottle was last opened ~ one month earlier.
- The bottle was not sent for disposal because it was not full.

- Waste bottle was tightly recapped following the observation of pressurization.
- Potential chemical reactions resulting from the mixing of incompatible waste streams not fully communicated.
- Absence of a regular laboratory waste disposal schedule.

- Purchase vented caps and teach students how/when to use them on waste containers.
- Develop schedule to have wastes disposed routinely through RMS.
- Review proper glassware cleaning techniques to remove metals and other contaminants to prevent cross contamination of waste.
- Conduct risk assessment on lab tasks and develop or enhance procedures as appropriate.
