# SAFETY ALERT

## Campus Incident—Laceration

**Event Date:** September 2016  
**Category:** Machine Safety  
**RMS Contact:** Randy Crist, [jcrist1@nd.edu](mailto:jcrist1@nd.edu)

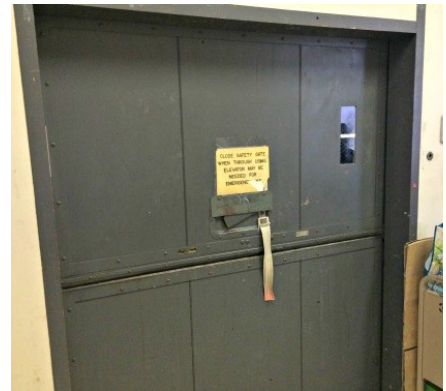
An employee was injured when their hand was caught between the closing doors of a service elevator resulting in a laceration that required over 30 stitches to close.

- The elevator doors close vertically by manually pulling on a canvas strap.
- The elevator design does not prevent a person from placing a body part in the doors' pathway.
- There are no signs indicating that the doors pose a potential hazard.

- Elevator design does not prevent occupants from placing body part in closing doors' pathway

- Conduct job hazard analysis within departments that use service elevators.
- Review safe operation of service elevators with all affected staff.
- Affix high-visibility warning tape on interior and exterior of vertically closing doors in all freight elevators
