# **SAFETY ALERT**

# **Chemical Fire**

Event:	Chemical Fire	
Date:	January 2015	
Category:	Fire/Chemical

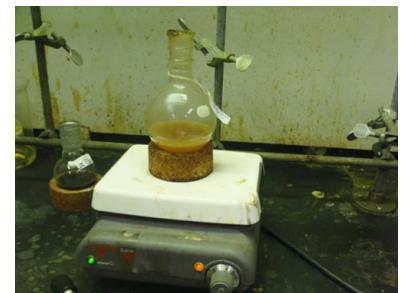
A small explosion and subsequent fire resulted during the quenching of sodium metal. The sodium was in a round bottom flask (See Photo 1). A graduate student quenched the metal with ethanol. The student poured some of the quenched material into the sink for disposal.

The small explosion and fire resulted because the mixture was not completely quenched and a piece of sodium dropped in the sink contacting water. The sodium metal reacted and the heat of reaction detonated the ethanol vapors. The fire was put out with a CO<sub>2</sub> fire extinguisher.

- The lab's Metals Quenching procedure did not outline a means for terminating the activity.
- The graduate student did not observe any sodium particles in the flask.

- Modify the current solvent drying and quenching SOPs to include quenching termination procedure.
- Conduct a PPE assessment. Train all lab personnel on PPE requirements.
- Outline when FR lab coats are to be worn and obtain FR lab coats for the lab personnel to use.
- Train lab personnel on new/modified procedures.
